RE: Preliminary Assessment Report for the Procino Plating site (DE-0344)

PRELIMINARY ASSESSMENT OF PROCINO PLATING

DE-0344 October 2010

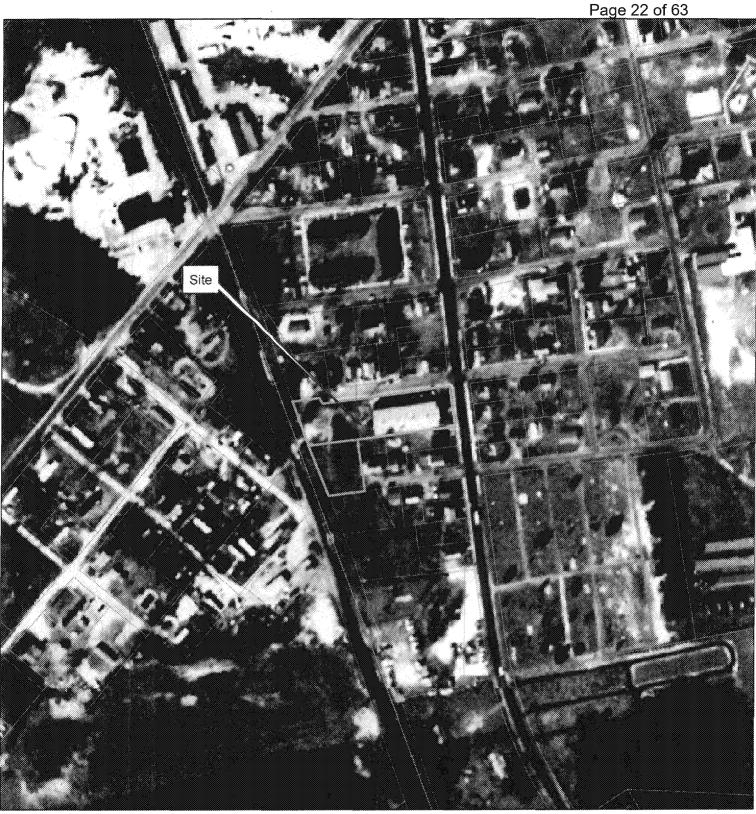
Figure 8 Procino Plating DE-0344

1992	The aerial photograph shows considerable change to the Town of Blades but the Site appears to be the same as in the 1968 aerial photo (Figure 8).
1997	The surrounding properties appear unchanged from the 1992 aerial photograph. The Site has, what looks like, two additional buildings on the western portion of the Site (Figure 9).
2002	The Site appears to remain unchanged with the exception of a shed like structure on the south side of the western buildings (Figure 10).
2007	The aerial photograph is concentrated on the Site. The surrounding properties appear to be unchanged from the 2002 aerial photograph. No changes were made to the Site (Figure 11).

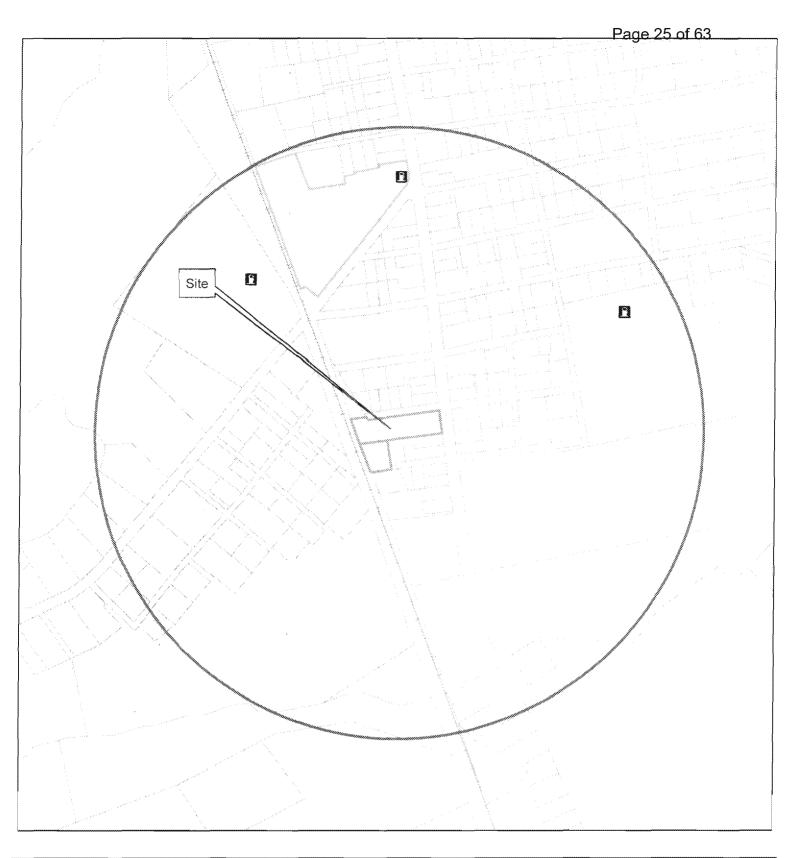
Figure 12 Procino Plating DE-0344

TMB – There are no documented above ground storage tanks (ASTs) or underground storage tanks (USTs) on the Site. There are three UST sites within a quarter miles of the site: Wyoming Concrete Industries, Bo-Win (Peninsula Plating), and Blades Elementary (Figure 12).

Other SIRB sites – There is one SIRB site located within a quarter mile of the Site, Peninsula Plating (DE-0287) located north of the Site (Figure 12).

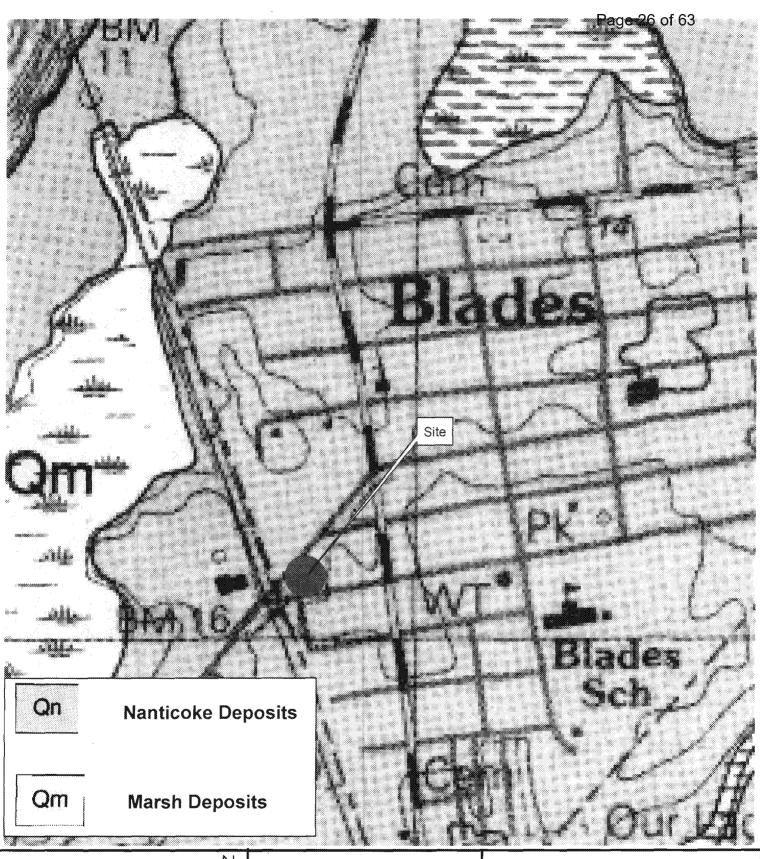
Figure 13 Procino Plating DE-0344

The St. Mary's Formation is made up of blue-gray, green-gray, or gray silty sandy clay, clayey sandy silt, and silty clay, with beds of fine to medium quartz sand, and fines to medium gravel I a mud matrix. This formation can be up to 110 feet thick (Figure 13).
